Forensic Assessments of the Nuclear Propulsion Plants of the Submarines HMS *Tireless* and RF Northern Fleet *Kursk*

John H Large

Large & Associates, Consulting Engineers

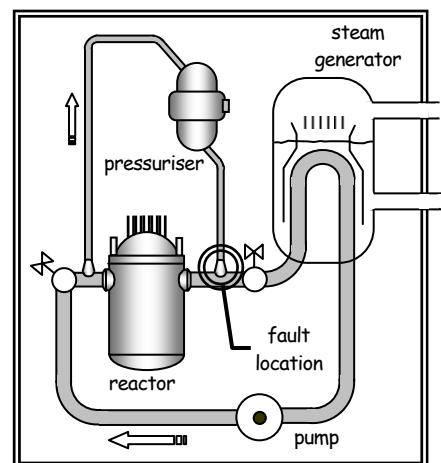
4 Schematic - Dispersed Nuclear Plant Main Components

The fault in the reactor primary circuit of *Tireless* was first detected by the *leak-before-break* systems on board the submarine when she was submerged. The leak was located in the immediate locality of the welded pintle tee-junction of the pressuriser surge pipe and the main outlet pipe feeding from the reactor to one of the steam generators. The reactor was shut down following prescribed procedures, and the leakage rate estimated. It was then decided at high level within Ministry of Defence (MoD) and communicated back to the boat that the reactor could be restarted and the boat continue nuclear operations. However, after a few hours of running the leakage

increased to an intolerable rate, suggesting rapid development of the leakage path, so much so that the nuclear plant was shut down again with the primary circuit being progressively depressurised whilst *Tireless* made for the Port of Gibraltar under her standby diesel plant.

If the fault had been allowed to develop further then *Tireless* would have been at very real risk of catastrophic failure of the surge pipe junction which, being located inboard of the primary circuit isolation valves, could allow the reactor pressure vessel to rapidly depressurise and starve of coolant. Uncontrolled loss of coolant at this locality could have resulted in boiling of the coolant remaining in the reactor vessel, overheating of the nuclear fuel (even with the nuclear process shut down because of the continuing residual heat from fuel decay), the possibility of fuel melting and, in the extreme, a violent explosion leading to a radioactive release within a few minutes.^{2,3}
